Queercon

~~2018~~ 1983

Badge Documentation

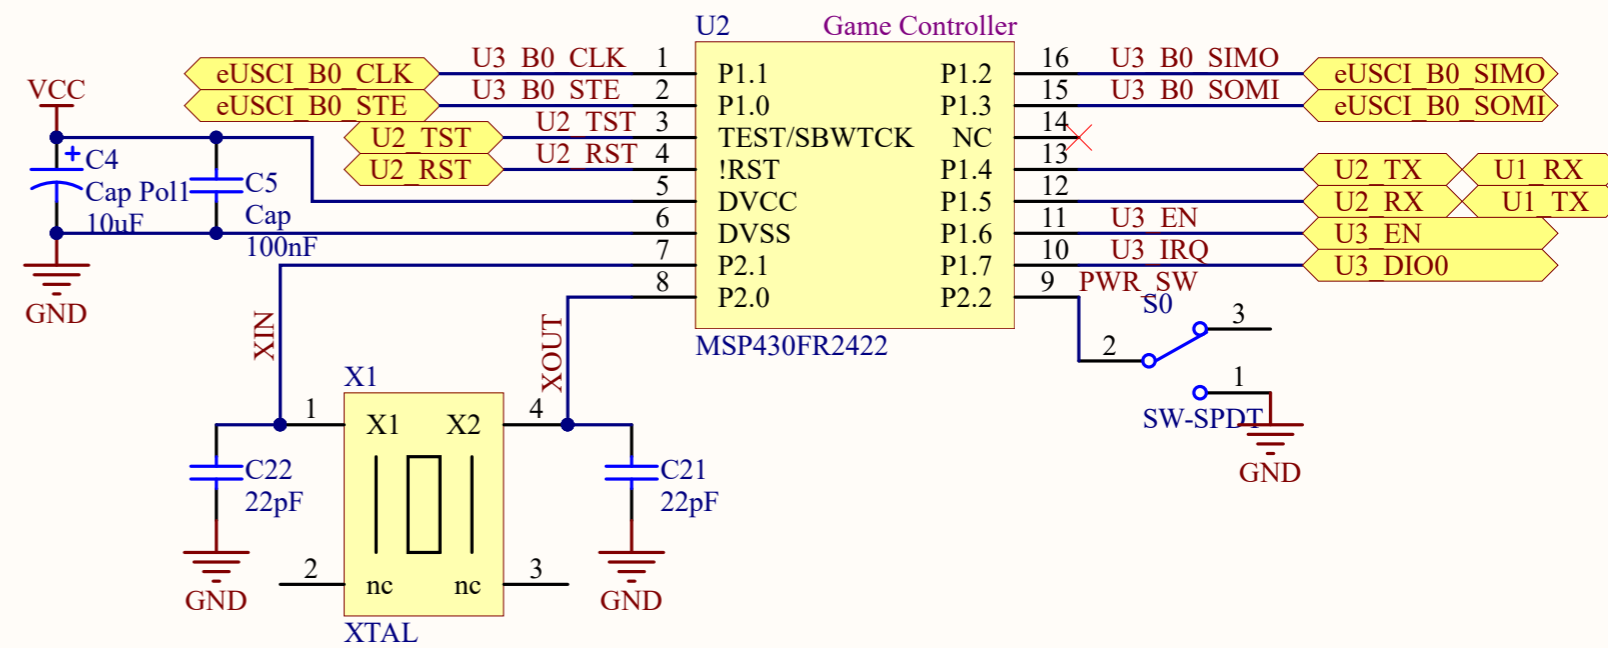
Title Main Controller			Queercon 2018 by Akio blinkylights.ninja	
Size: Letter	Number: NA	Revision: B0	*	
Date: 8/6/2018	Time: 2:40:13 PM	Sheet 1 of 4	*	
File: D:\Dropbox\Queercon\QC15\2018 Badge Altium\1 MainController_rB0.SchDoc

$$R2 = 123 * R1 / (100V_{out} - 123)$$

BOM is document of record on all part numbers and values

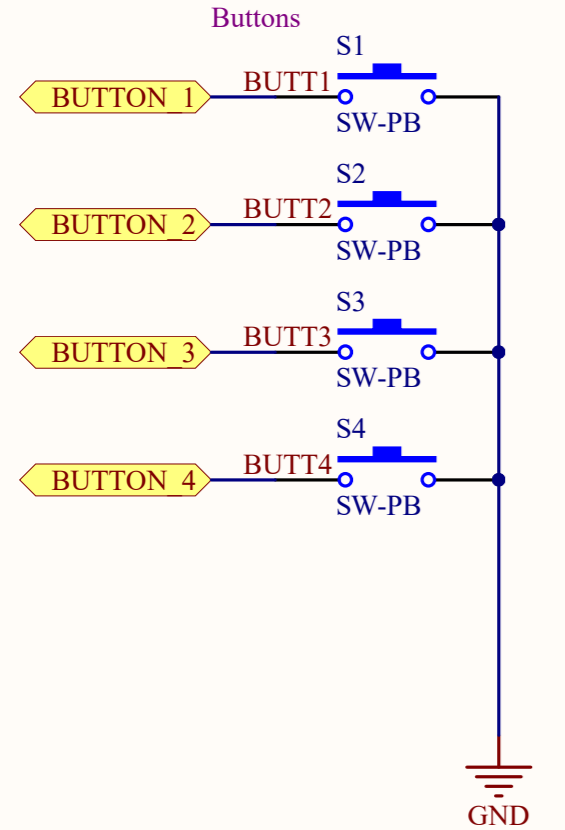
Title Display Controller			Queercon 2018 by Akio blinkylights.ninja	
Size: Letter	Number: NA	Revision: A1	*	
Date: 8/6/2018	Time: 2:40:13 PM	Sheet 3 of 4	*	
File: D:\Dropbox\Queercon\QC15\2018 Badge Altium\2 DisplayController_rA1.SchDoc

BOM is document of record on all part numbers and values

LED driver POST FAIL A simple mode-set command on the LED driver (HT16D35B, U4) has failed to return the expected result. This means the driver has failed, or there is a problem with I2C communication between U1 (MSP430FR5972) and U4. Try a power cycle first as there is a small chance this is a bus error that the software may be able to auto-recover from. Also check the pull-up resistors (R6 and R7.)

SPI NOR flash POST FAIL A very basic test of SPI communication with the external flash has failed. This test reads the model number, then tries to enable and disable writing to the module. If this fails, it is likely that the flash module, or the SPI connection to it, has failed.

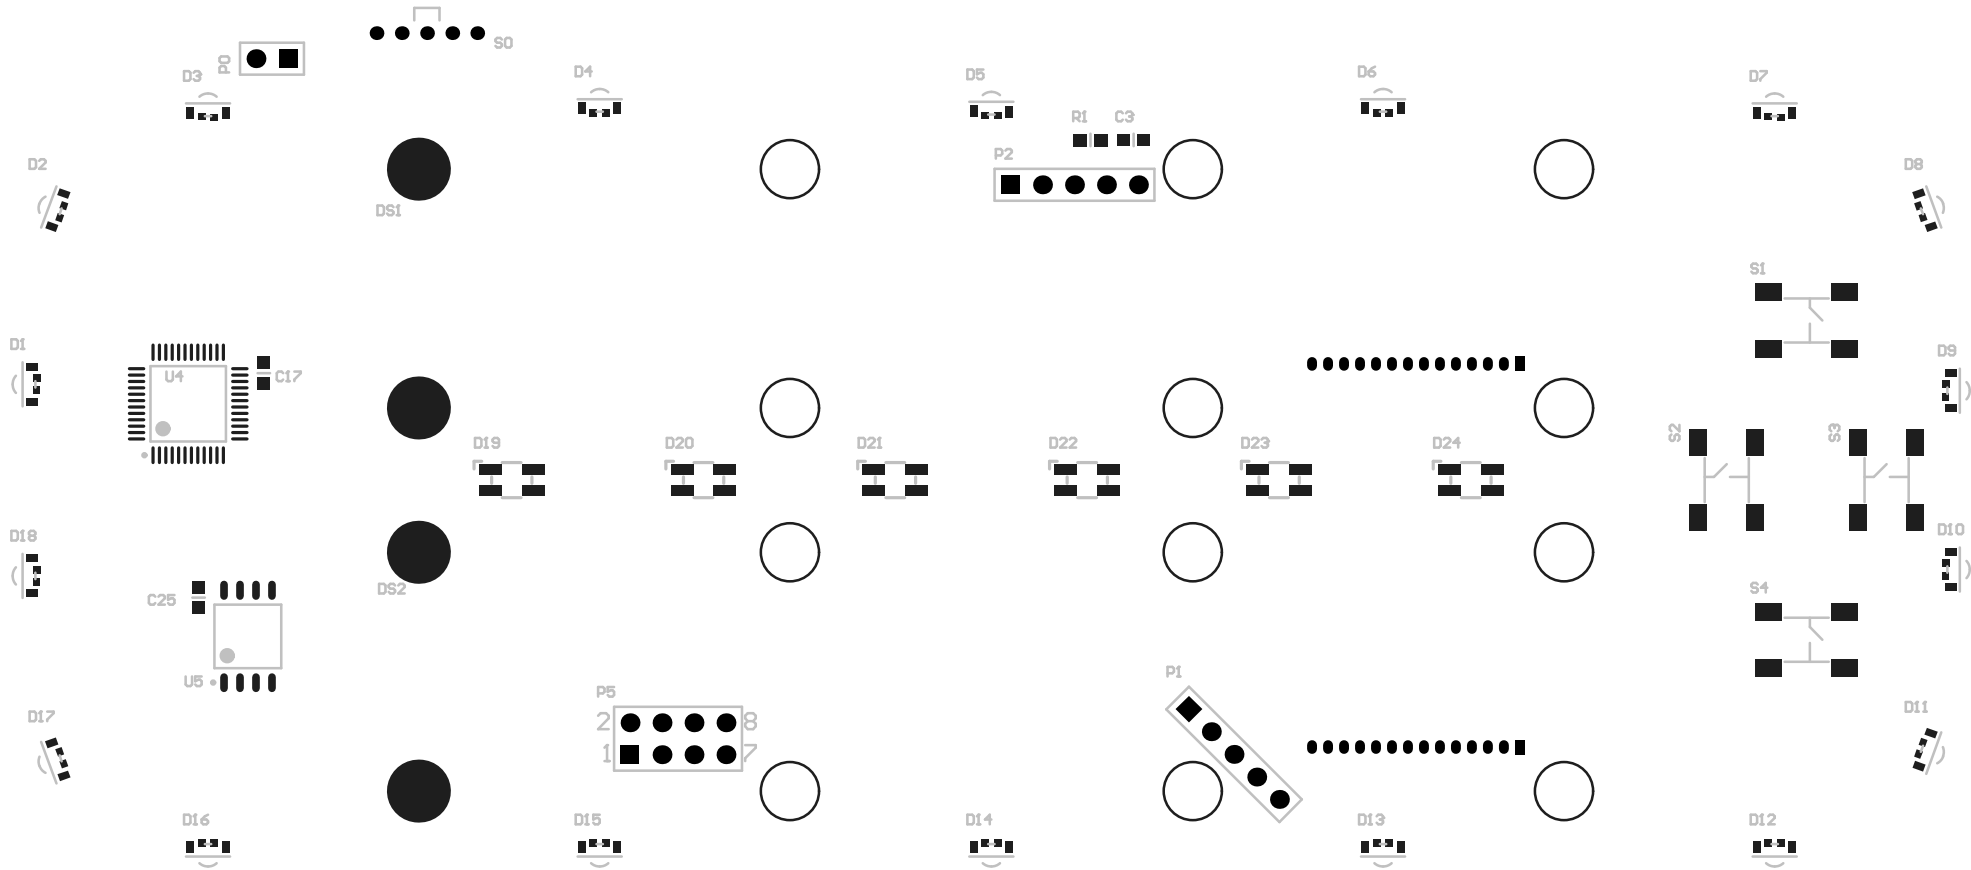
QUEER CON 15

rc1 - queercon 15 - 2018 - - blinkylights.ninja - queercon.org
